NEW HAMPSHIRE COASTAL BASIN  
NEWMARKET, NEW HAMPSHIRE

MACALLEN DAM  
NH 00365

PHASE I INSPECTION REPORT  
NATIONAL DAM INSPECTION PROGRAM

MARCH 1980

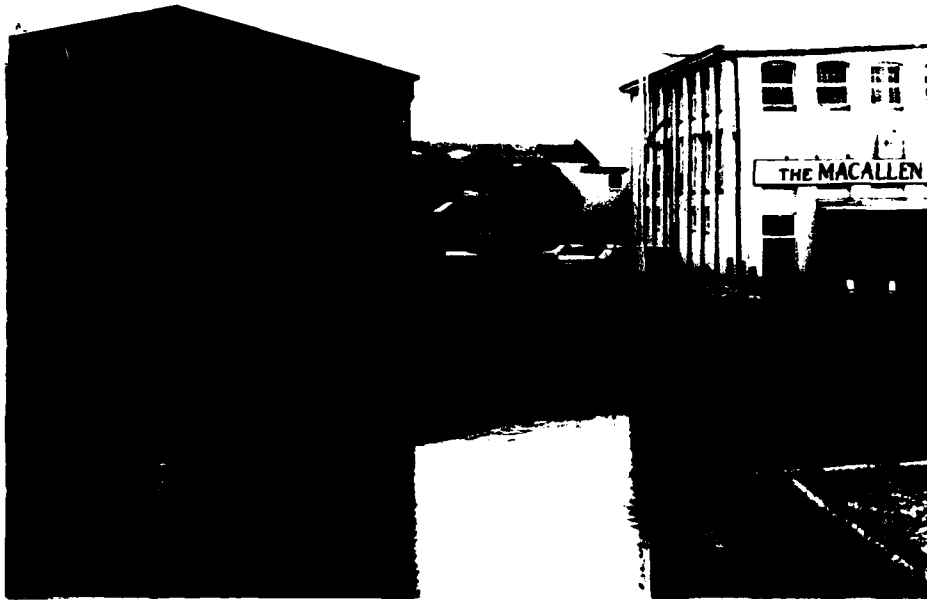
b. Dam. Macallen Dam, the spillway and walls retaining the earth fill, appear to be in good condition, Photos Nos. 2 and 3. The spillway was free of debris. However, there was a partially sunken log in the approach channel, Photo No. 1, which had been viewed at the same location during a prior visit to the site on 8 September 1979.

2. Left side of dam, upstream

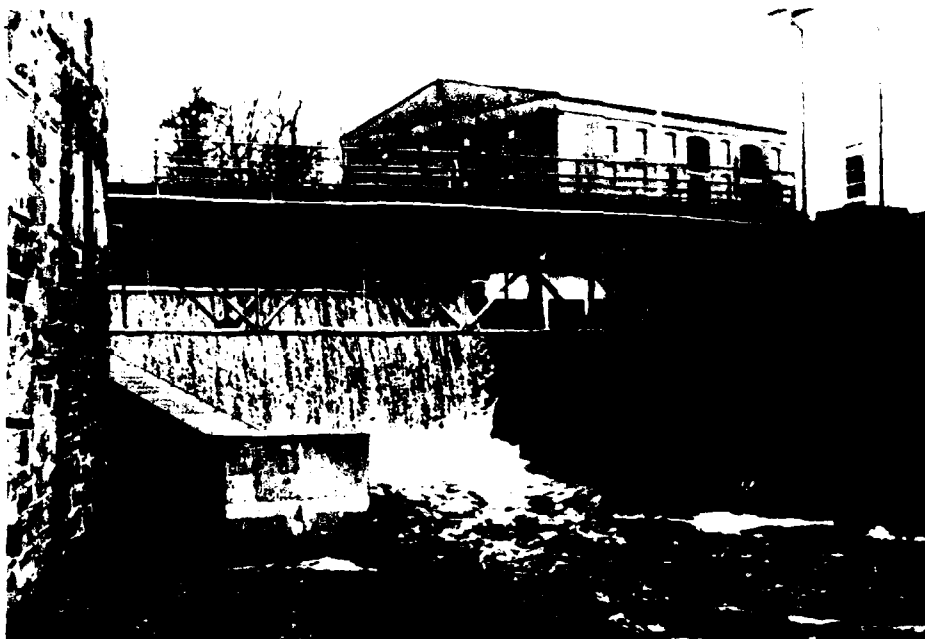
c. Appurtenant Structures. The stone masonry walls of the downstream channel appeared to be sound and in good condition, Photos Nos. 4 and 6. However, slight seepage was observed moistening the top surface of the lower stone masonry building wall adjacent to the fishladder (see Appendix page C-1). The water was clear and the slight flow appeared to be constant. The seepage may be from a filled canal within the right abutment area, from natural drainage or from some other source.

4. Downstream channel and left side of dam

1. Complete the repairs on the operating mechanism of the center waste gate.
2. Monitor the slight seepage along the right wall of the downstream channel such that the flow can be correlated with reservoir level. If the seepage flow is noted to increase without apparent reason, the Owner should then engage a registered professional engineer to investigate the condition. All observations should be made part of a permanent record.
